ARBORICULTURAL REPORT:

BS 5837 – 2012

TREDILION PARK

Project: Tredilion Park		
Project Number	L078	
Title	Arb Report	
Document Number	L044 - Arb Report-V3.2	
Client	EMMA VIDLER	
Issue Date	01 September 2025	
Prepared by:	David Price	01 September 2025
<p>This report has been prepared by Sylvan Ecology, with all reasonable skill, care, and diligence within the terms of the Contract with the client.</p> <p>We disclaim any responsibility to the client and others in respect of any matters outside the scope of the above.</p> <p>This report is confidential to the client and we accept no responsibility of whatsoever nature to third parties to whom this report, or any part thereof, is made known. Any such party relies on the report at their own risk.</p>

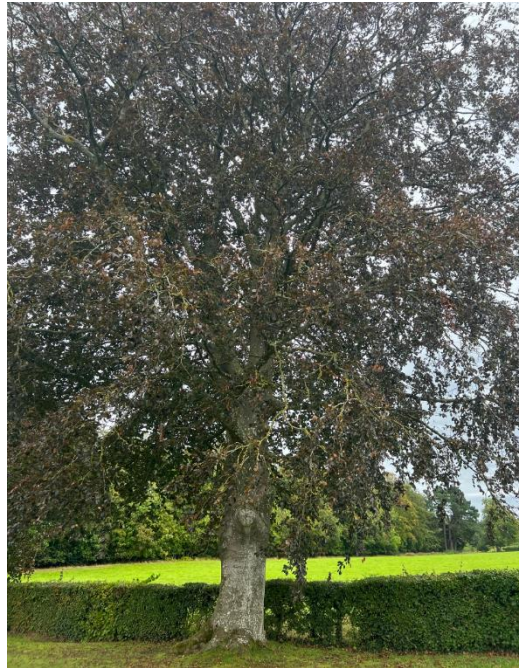
3.4

Photo 1: Overview of T13 Cat B beech.

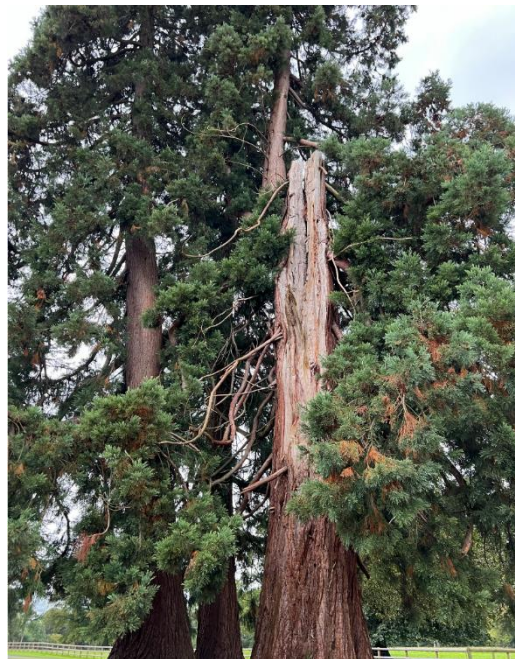
3.5

Photo 2: Overview of G1 Cat B group with storm damage.

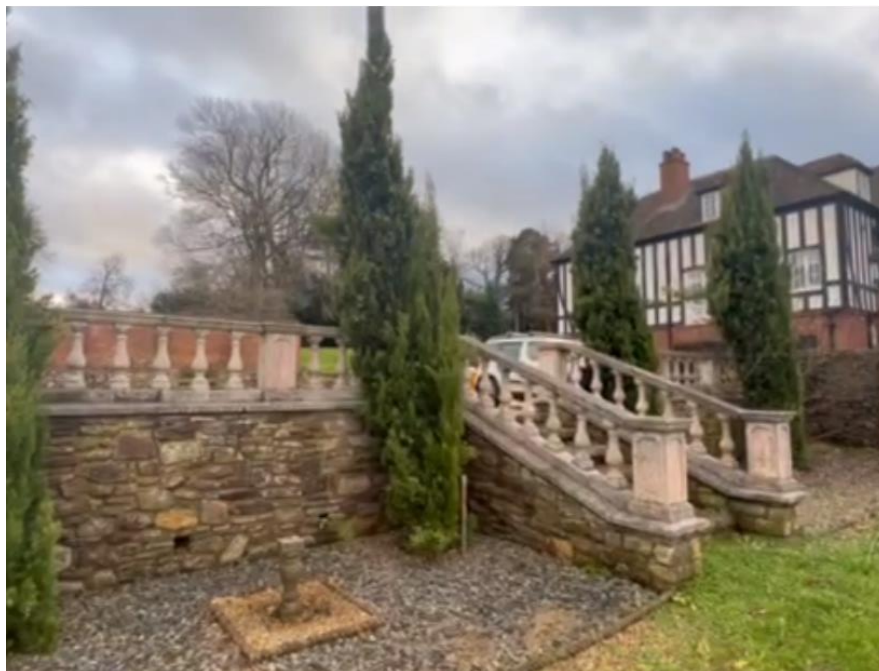
3.6

Photo 3: Overview of T1, T2, T3 and T4

- T1 - T9: the small ornamental cypress trees will need to be removed to accommodate the development.
- T11: The fig tree is too close to the proposed development and is likely suffer significant damage, it's recommended it be removed.
- T12: The fruit tree is too close to the proposed development and is likely suffer significant damage, it's recommended it be removed.
- T14: The ash tree is too close to the proposed development but is also infected with ash dieback.
- T15: The chestnut tree is close to the proposed development, the tree is large, mature has some minor crown dieback with some dead branches in the canopy. The falling large branches would fall onto the proposed development so its recommended it be removed.
- T16: The ash tree is too close to the proposed development but is also infected with ash dieback.
- G3: will need to be removed to accommodate the development.

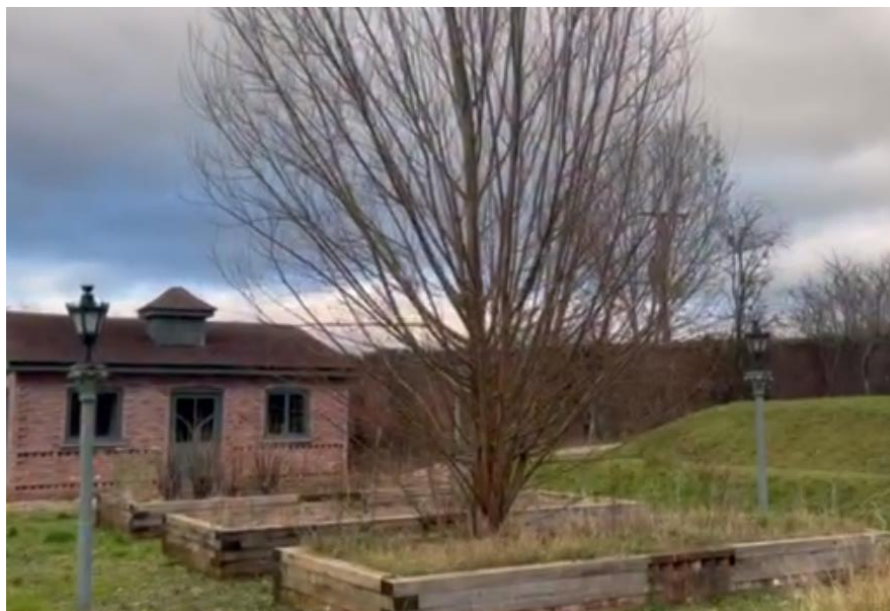
3.7

Photo 4: Overview of T10 Cat C self-sown willow within raised bed.

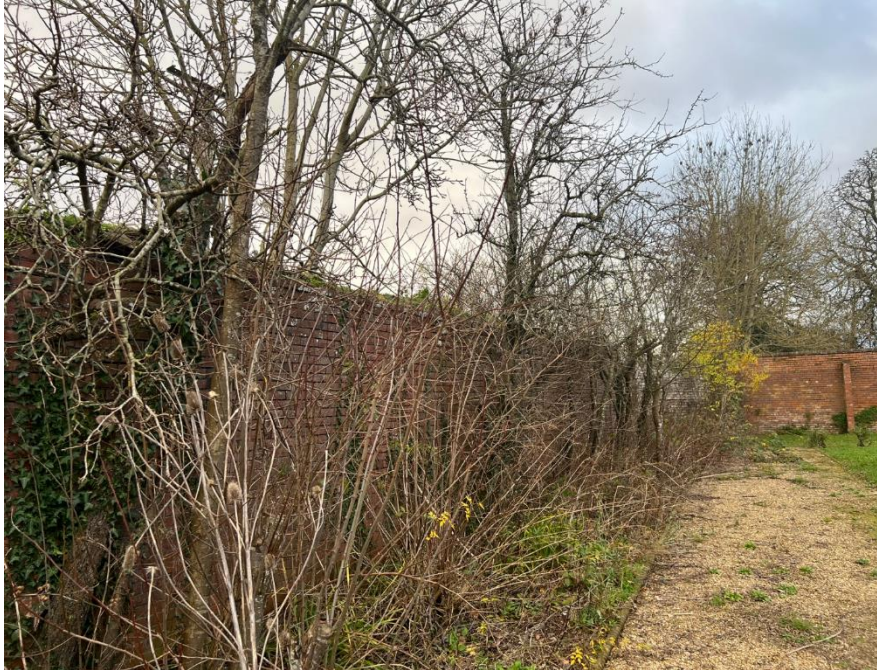
3.8

Photo 5: Overview of G3, fruit trees with scrub.

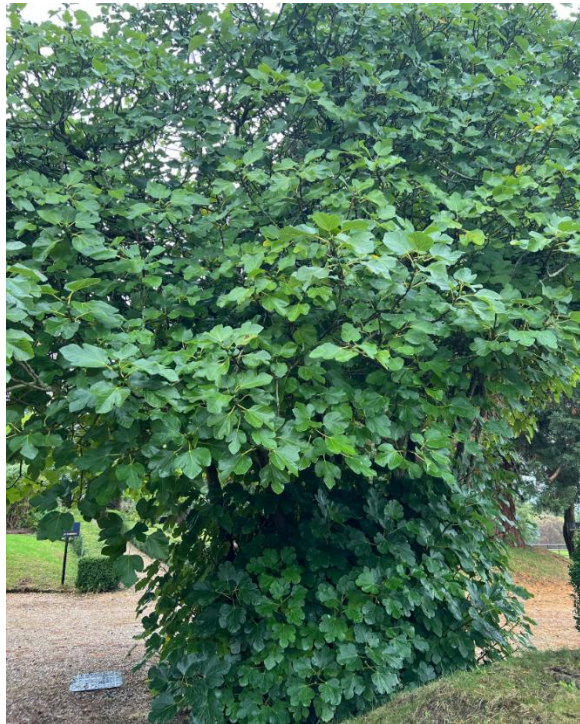
3.9

Photo 6: Overview of T11 Cat C Fig tree.

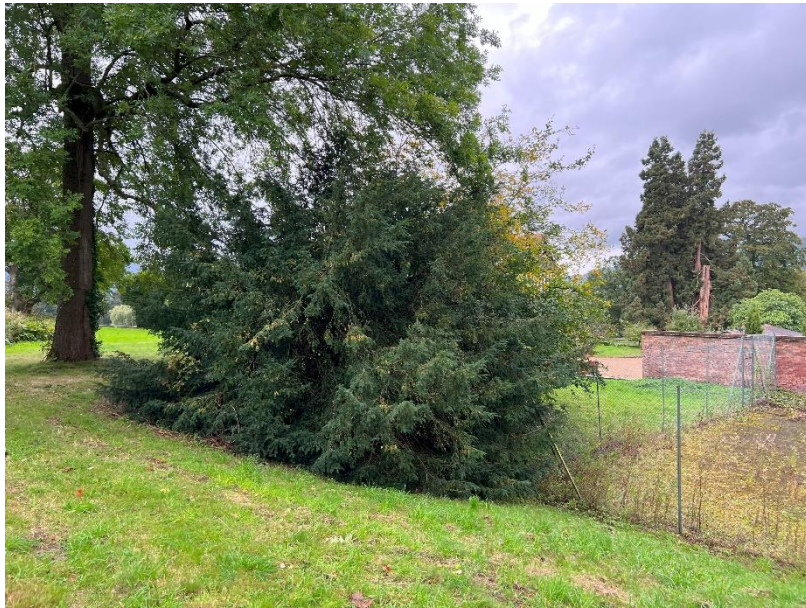
3.10

G5	Cat C1	Small group consisting of a yew shrub and an ash tree (T16).

Photo 7: Overview of G5

- 4.10 Groups G4 and G5 may need to be cut back to allow access for the development. The tree has previously been regularly, roughly cut back to allow such access. All tree surgery works will be undertaken prior to construction activity and in accordance with the Arboricultural Method Statement section: Remedial Tree Works. Once allocated trees have been felled, it is anticipated that no further pruning work will be required, all works will be undertaken to BS 3998 (British Standard Recommendations for Tree Work 2010).

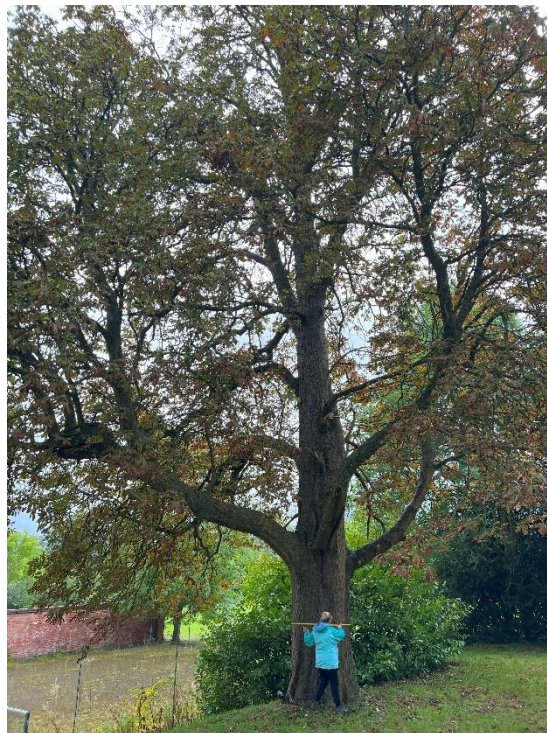
3.11

Photo 8: Overview of T15, Cat B chestnut.

- 4.17 The loss of T15 and the other trees will be compensated for by planting ten trees. The planted trees will consist of feathered whips (circa 1.2 m tall); all planted stock should, as far as is reasonably possible, be locally sourced and of appropriate local provenance (as defined by Forestry Commission Practice Note [1999] Using Local Stock for Planting Native Trees and Shrubs). The location of the trees will be detailed with the landscape plan.
