BAT ECOLOGY SURVEY REPORT

TREDILION PARK

Project: Tredilion Park		
Project Number	L078	
Title	Bat Survey Report	
Document Number	L078- Bat Report-V1.3	
Client	EMMA VIDLER	
Issue Date	01 September 2025	
Prepared by:	David Price - Consulting Ecologist	01 September 2025
Approved by:		
<p>This report has been prepared by Sylvan Ecology, with all reasonable skill, care, and diligence within the terms of the Contract with the client.</p> <p>We disclaim any responsibility to the client and others in respect of any matters outside the scope of the above.</p> <p>This report is confidential to the client and we accept no responsibility of whatsoever nature to third parties to whom this report, or any part thereof, is made known. Any such party relies on the report at their own risk.</p>

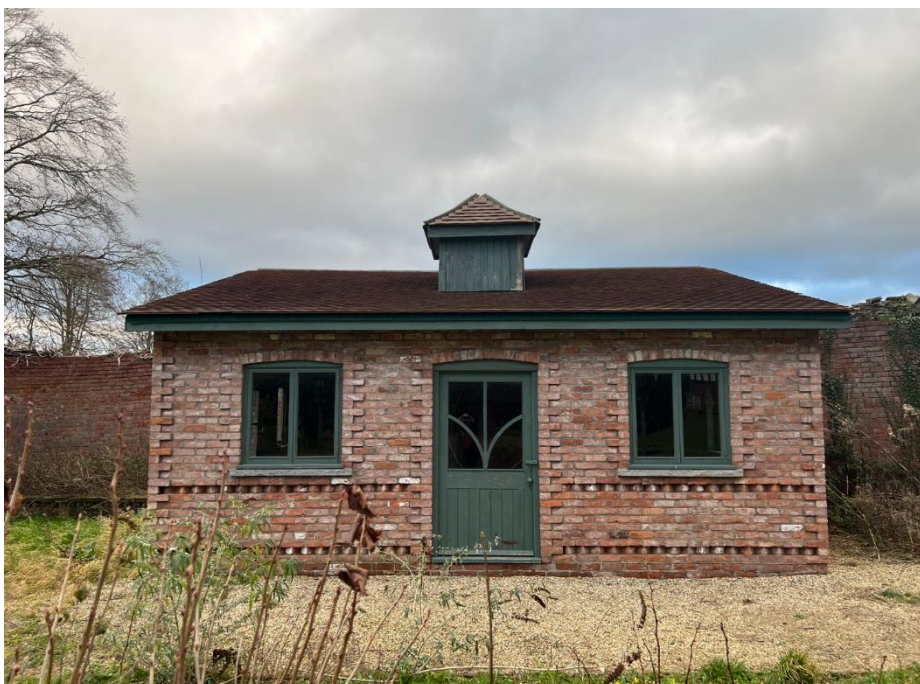
Building ref	Evidence	Description of building	Roost potential
3	None	Potting shed: Small new building. The roof has been recently replaced however, works appear incomplete in places and access exists onto the breathable membrane. There is some flashing and external wooden cladding, both were inspected and showed no sign of bats, however they do offer low potential for roosting species. The building has a cupola on top, but it appears ornamental and doesn't seem to offer access to the building. The building is incomplete and there is extensive internal damp.	Low

Photo 1: Shows an overview the potting shed.

- 4.1 Given the results of the survey, it is considered that these building are not currently being used as bat roosts. Therefore, any redevelopment of these buildings is unlikely to result in any impacts on bats and it is considered that an EPS Licence will not be required.
- 4.2 These buildings are considered generally unsuitable for hibernation, however little is known about pipistrelle hibernation roosts, so the fact that bats may hibernate in the structures cannot be discounted. Though no evidence of bats was found within the building, due to the transient nature of many species, it is recommended that contractors be made aware of the presence of bats in the area. Should a bat be found, advice should be sought from a suitable experienced ecologist.

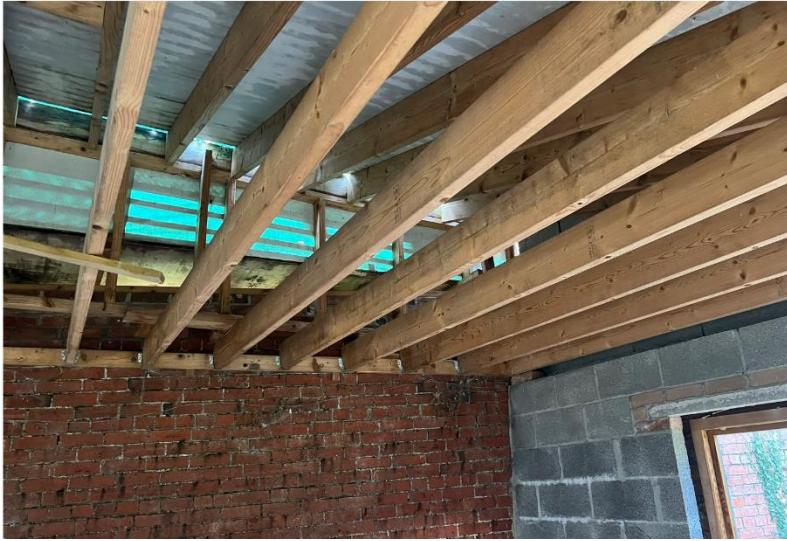
Photo 2: Shows the inside the roof of the potting shed.

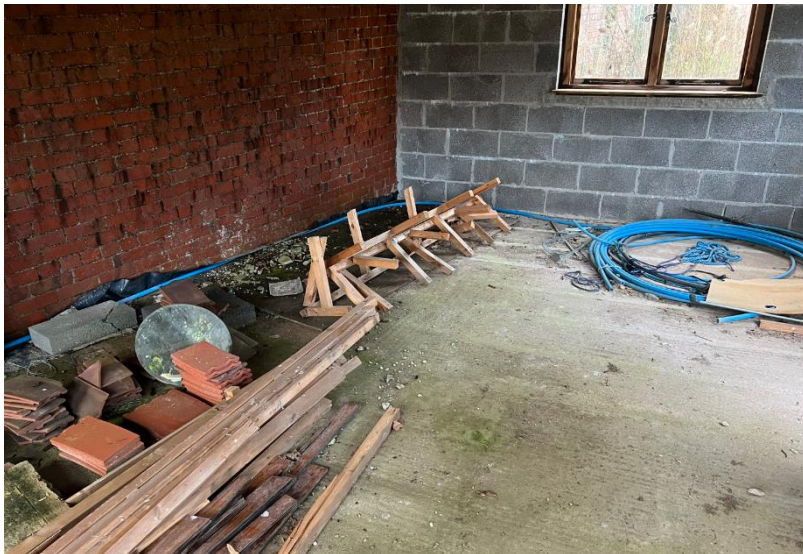
Photo 3: Shows the inside of the potting shed.

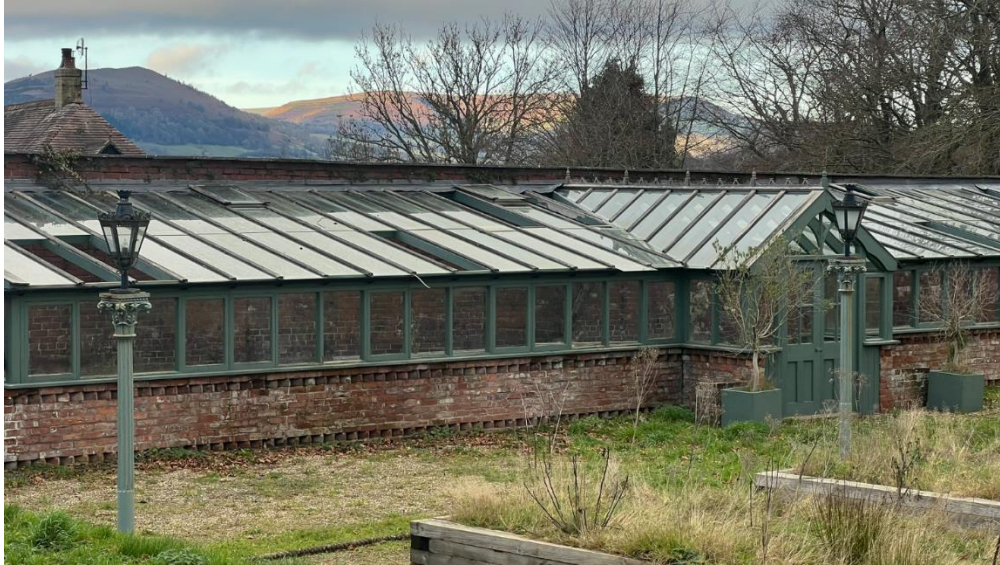
4	None	Greenhouse: Wood and brick greenhouse. The glass is held in place with wooden boards, there are small gaps along the boards which may offer opportunities for roosting bats. There is lead flashing along the wall, with a small gap behind it that may offer opportunities for roosting bats. All features were inspected, no evidence of bats was found	Low
---	------	---	-----

Photo 4: Shows an overview of the greenhouse.

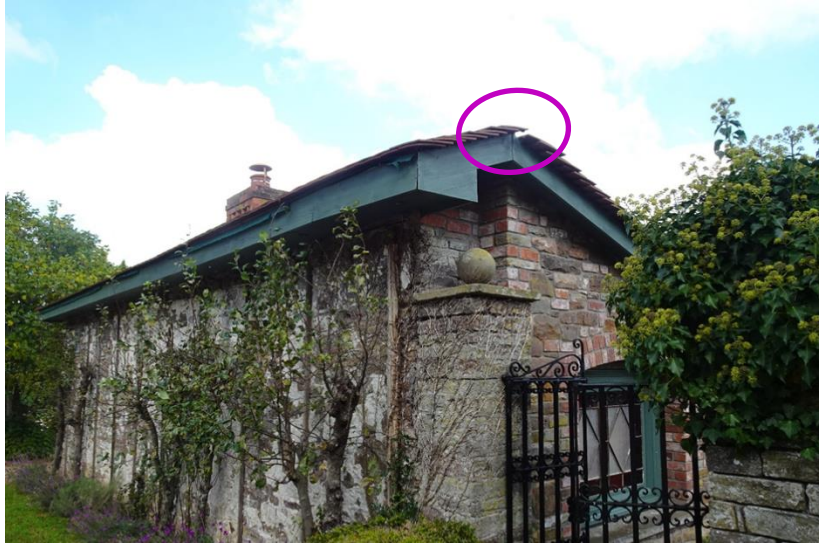
5	None	Garden store: Building has been converted into a dining area with industrial oven. The roof has been recently replaced however it is in poor condition in parts. The building is in generally good order, the only access point are from the roof. No evidence of bats was found within the building.	Low
---	------	---	-----

Photo 5: The pink circle highlights some of the slipped roof tiles.

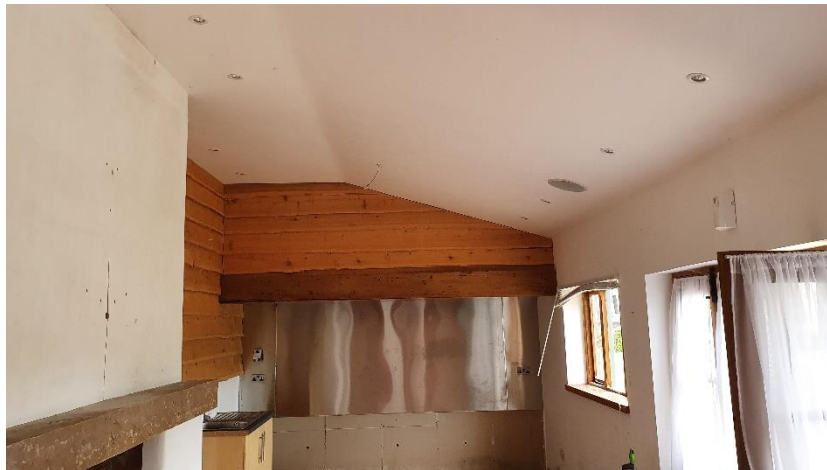
Photo 6: Inside the garden store.
